KOOTENAI DEVELOPMENT IMPOUNDMENT DAM
OCTOBER 2011 ROUTINE OWNERS INSPECTION

Prepared for: The Remedium Group

Prepared by: Kurt Hafferman, P.E.

Inspection Date: November 01st, 2011
Report Date: January 12th, 2012

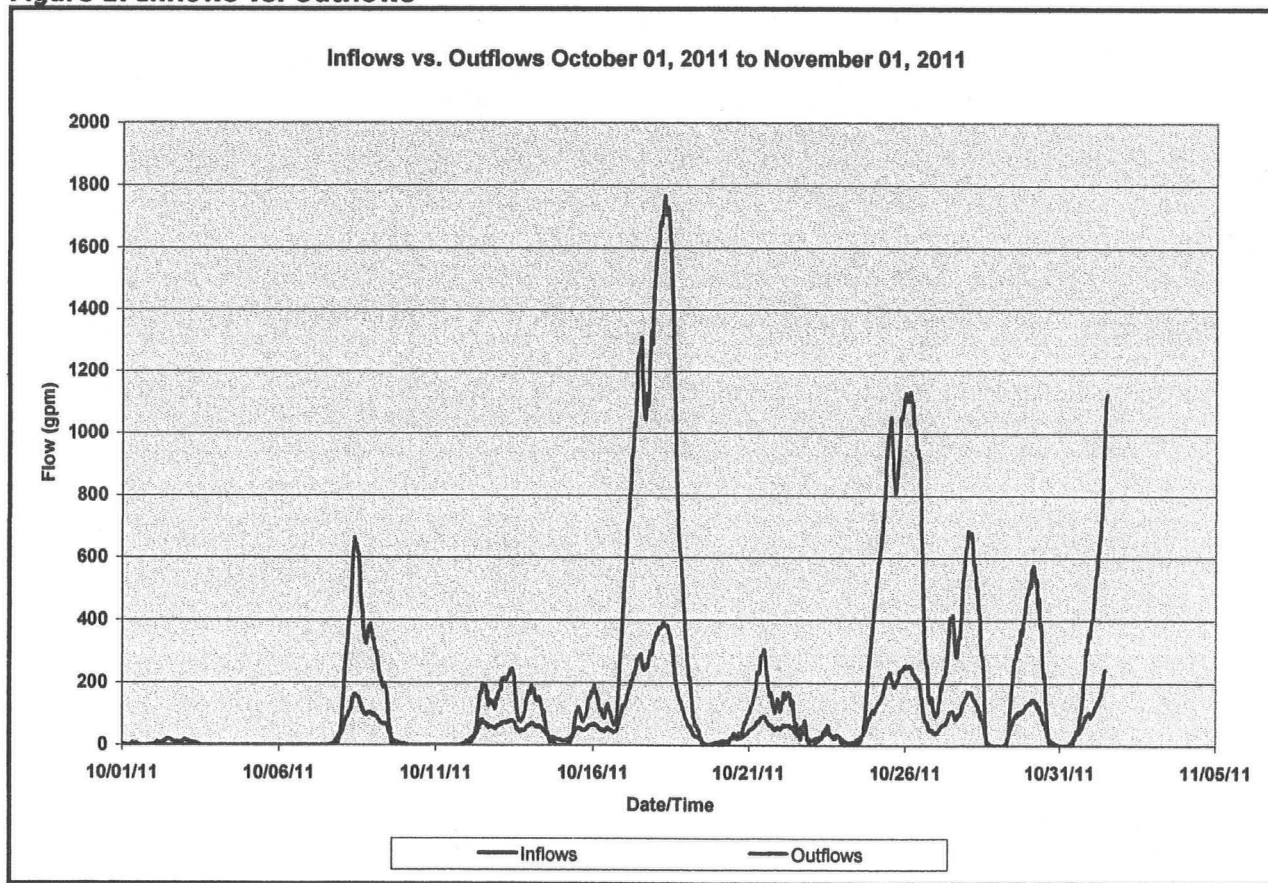
Figure 1: Inflows vs. Outflows

Review of transducer data this month revealed a similar inflow-outflow pattern as in past months. However the data collected over the past month indicated that inflows and outflows reached zero gallons per minute repeatedly over as shown above; which is not realistic.

After review of other transducer data and making calls to the Solinst® engineers, it was determined that the fluctuations in water levels are assumed to be caused by the more rapid barometric pressure changes that are typical of fall weather patterns in this part of the country and at this elevation. BHI noted to the Solinst® engineers that through the summer months we did not see negative flows or rapid transducer responses and the Solinst® engineers stated that typically summer barometric pressure changes were fairly constant and must have balanced from month to month. As seasonal fluctuations occur, readings should be barometrically adjusted to ensure accuracy and the transducer cleared of data and reset as part of each site visit to minimize the barometric lag effects. BHI purchased a barologger and it was placed onsite to provide readings to make the barometric compensation in next months transducer data. The Solinst® engineers stated that while the uncorrected data does not reflect exactly accurate flows, the magnitude of the data is still relevant and the corrections will be the same for all transducers; upstream and down stream.

Of note in Figure 1 above is that we can continue to see that outflows exceed inflows. Inflows include Upper Rainy Creek and calculated Fleetwood Creek flows and outflows include toe drains and any groundwater infiltration below the toe of the dam. Based on the data collected outflows exceeded inflows by 30% in October and show continued groundwater influence on the drain system. Figure 2 below shows the inflows and outflows along with the flows recorded at LRC-02 below the mill pond.

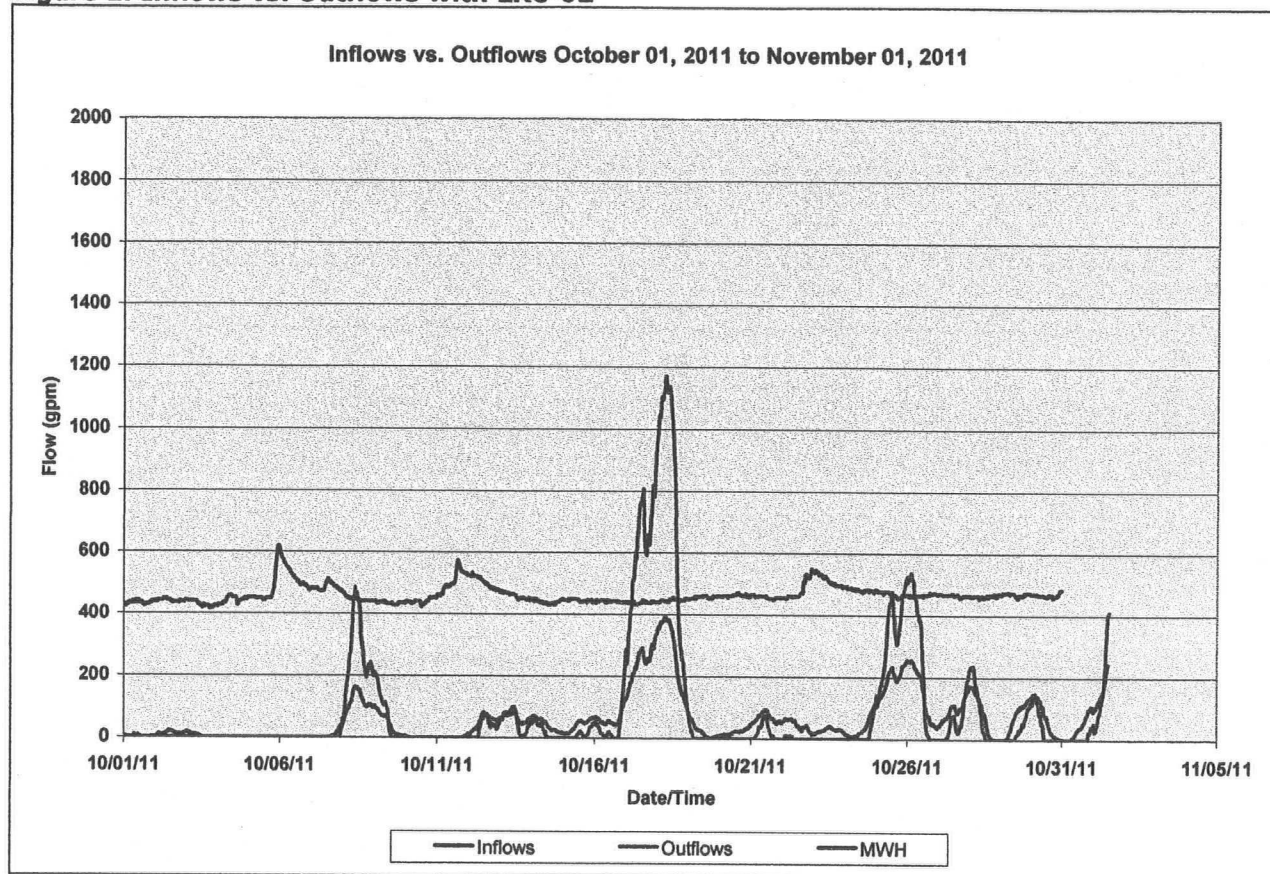
Figure 2: Inflows vs. Outflows with LRC-02

The graph above is the same as Figure 1 except it includes the flow data obtained from MWH Global for the LRC-02 flume which sits below the mill pond. LRC-02 is measuring the same water as LRC-01 except for the addition of any additional groundwater discharges and, as previously stated, the Carney Creek flows have been removed in the graph data above. MWH flow data is only collected during spring and summer months each year and data collection ended on October 31, 2011. MWH data is collected by ISCO samplers and should not be subject to barometric changes at the site.

The MWH data indicates that outflows from the dam were 31 AF from October 01, 2011 to October 31, 2011 as compared to the 12.1 AF calculated at LRC-01 by BHI and as further compared to the 8.6 AF of total surface water inflows. The flow measurements at the MWH ISCO sampler at LRC-02, as they do not require barometric pressure compensation, likely provide the most accurate measurement of flow rates and flow volumes. As can be seen, both the BHI data and the MWH data show a significantly greater volume of water flowing below the KDID embankment than flows in surface water from Upper Rainy Creek.

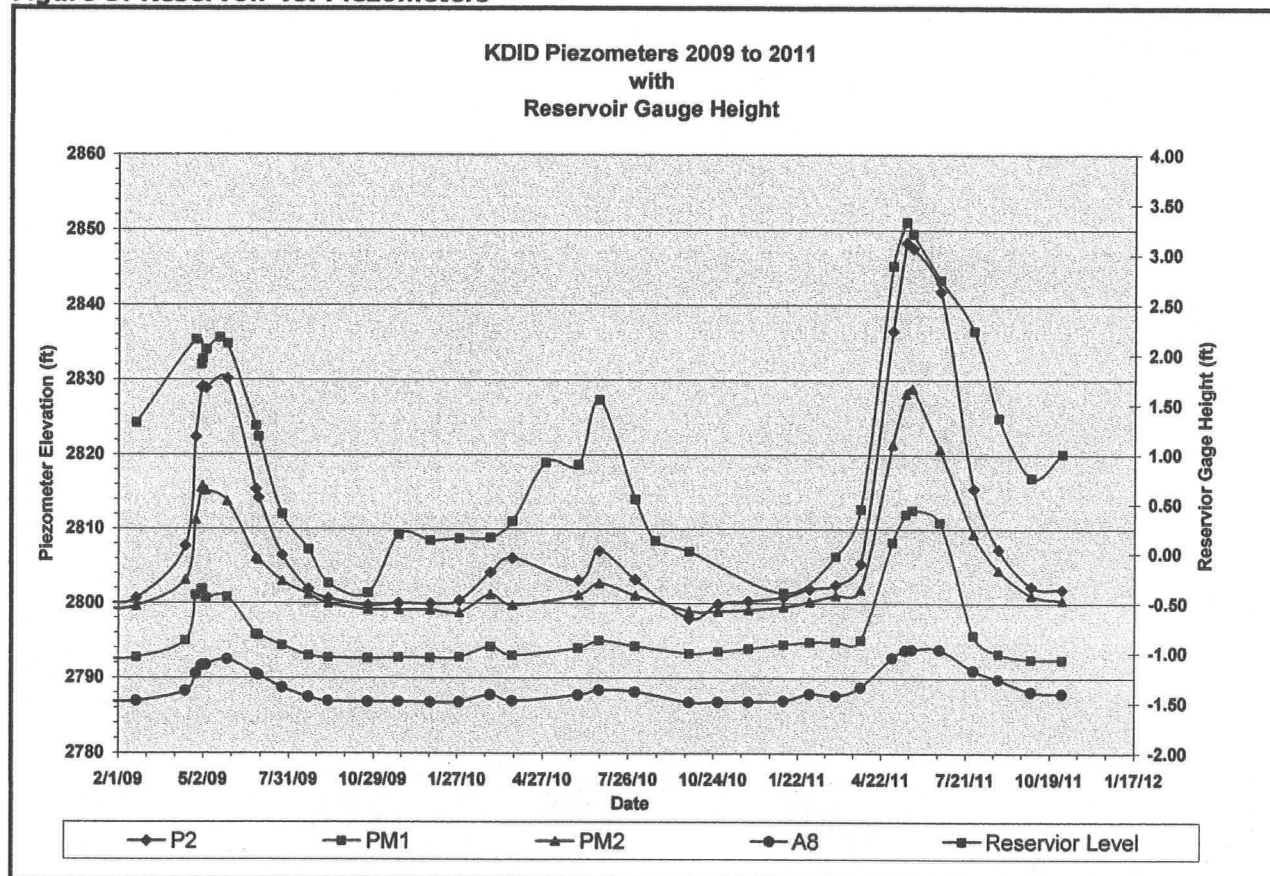
Figure 3: Reservoir vs. Piezometers

As shown above, the reservoir had been falling and all the piezometer levels are flattening as is typical for this time of year. The reservoir level, just like the piezometer levels are still approximately 1 foot higher than has been normally recorded by BHI for this time of year. Reservoir levels at this time of year are typically near 0.00 feet on the staff gauge or below and have never been noted to show a rise in levels in October. We typically do not see any rises until near December as shown in 2009 in the graph above. With the exception of 2010, the reservoir level does not generally fluctuate significantly from December to May when spring runoff begins. If the current reservoir level is sustained through the winter, and the wetter conditions persist, then spillway flows next spring could be higher than this year because of the higher pre-runoff reservoir level.

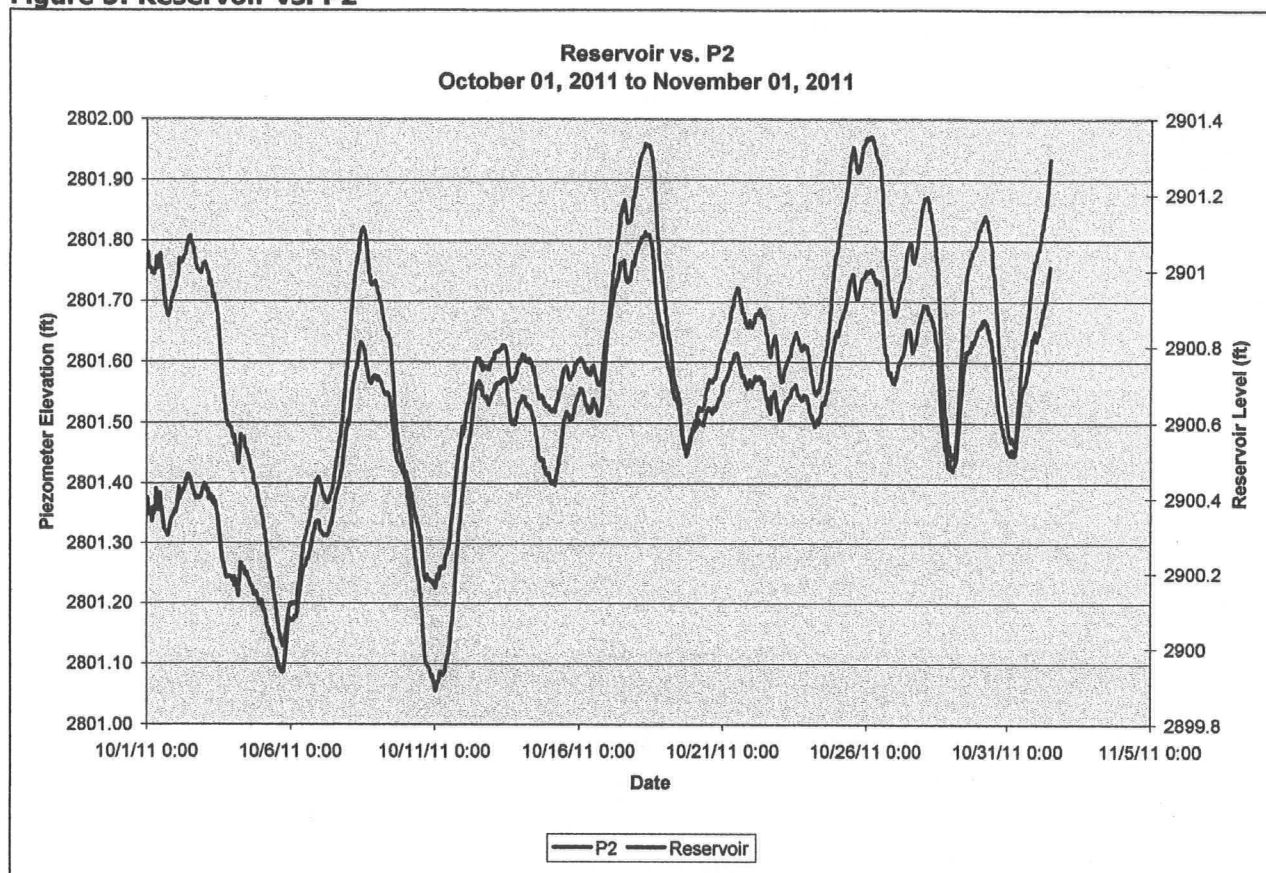
Figure 5: Reservoir vs. P2

The graph above, as in previous months, shows piezometer reactions are unnaturally similar to reservoir changes. Although the elevations and reservoir variations of 0.8 feet are not that unusual for time of year, the unusual part is the changes in reservoir level and the supposed phreatic water surface track so close with no apparent lag time. The graph above, as with all the on-site transducer readings above and below the reservoir, indicates, as discussed above, that there are barometric pressure influences. We know that the beginning and ending measurements are correct as they are taken manually by BHI, but the intermediate readings need to be corrected to remove barometric influences as suggested by the Solinst® engineers. The barologger placed this month will confirm the interaction with barometric pressure and reservoir level readings in next month's readings.

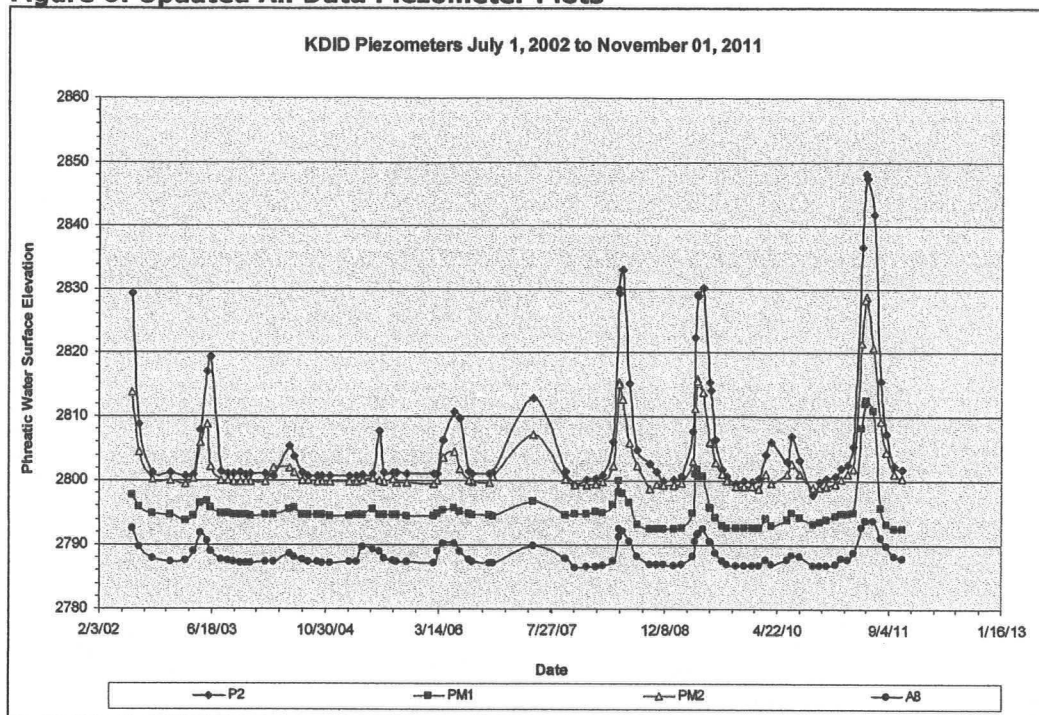
Figure 6: Updated All Data Piezometer Plots

The graph above shows that the phreatic water surface is returning to seasonally stabilized levels and the annual cyclic changes that occur on the project are reoccurring. Figure 7 below shows the same piezometers, but only includes the data gathered by BHI over a shorter period of time.

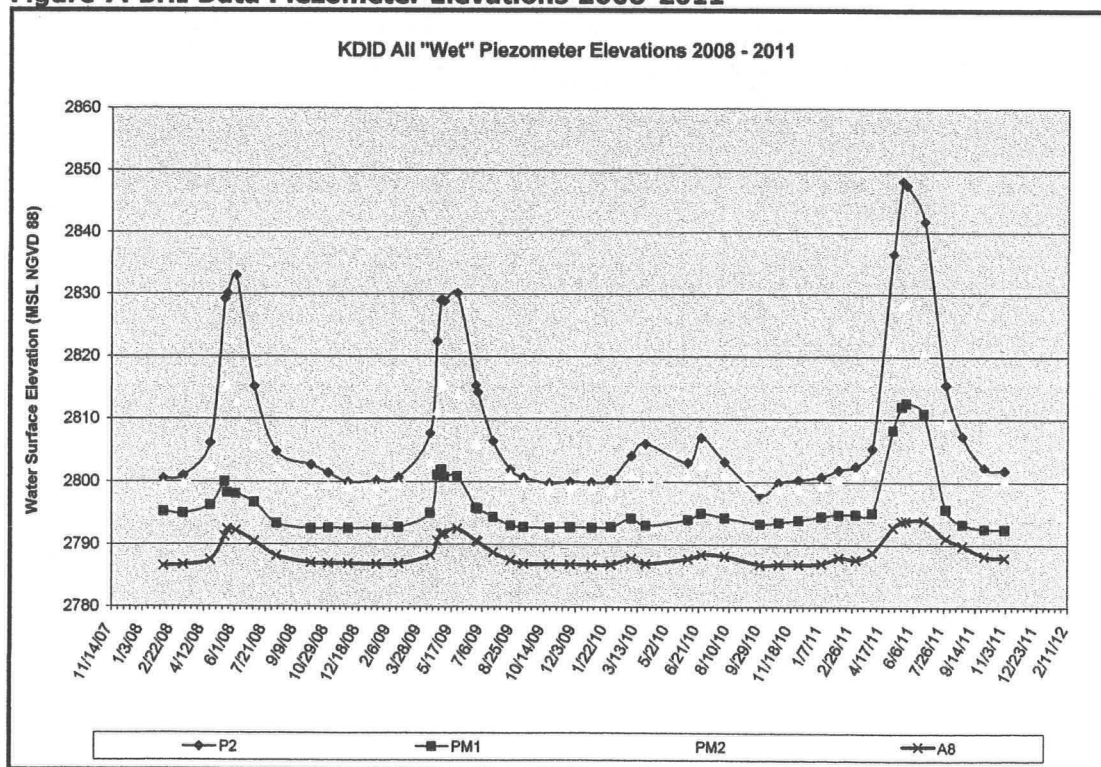
Figure 7: BHI Data Piezometer Elevations 2008-2011

The graph above continues to show that piezometer A8 is dropping slower than the other piezometers on the site and shows the phreatic water surface at the toe of the dam is still higher than has been previously recorded. Water levels this year at A8 have risen higher and fallen slower than past years and indicate the volume of groundwater still present and moving below the dam. Figure 8 below shows piezometer A8 with the toe of the dam.

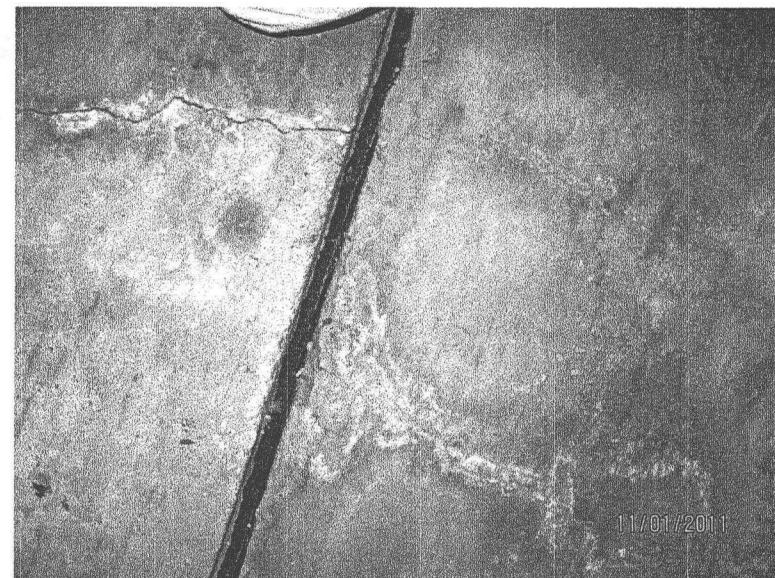
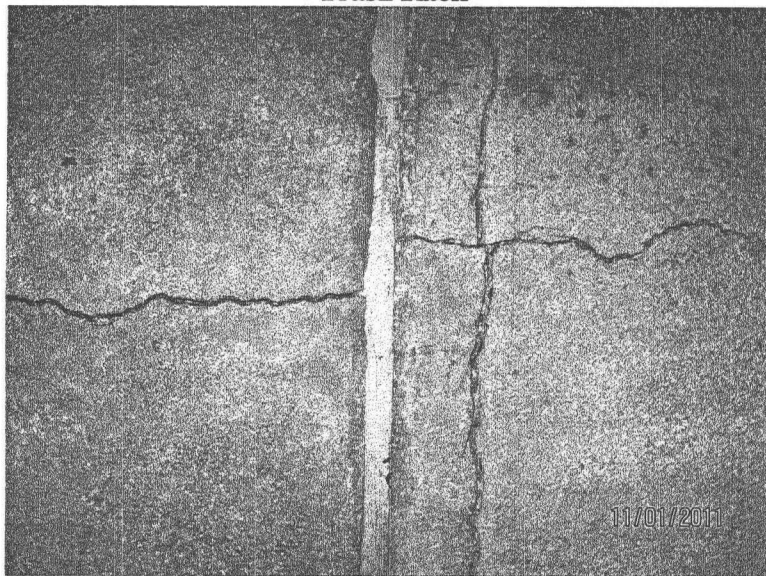
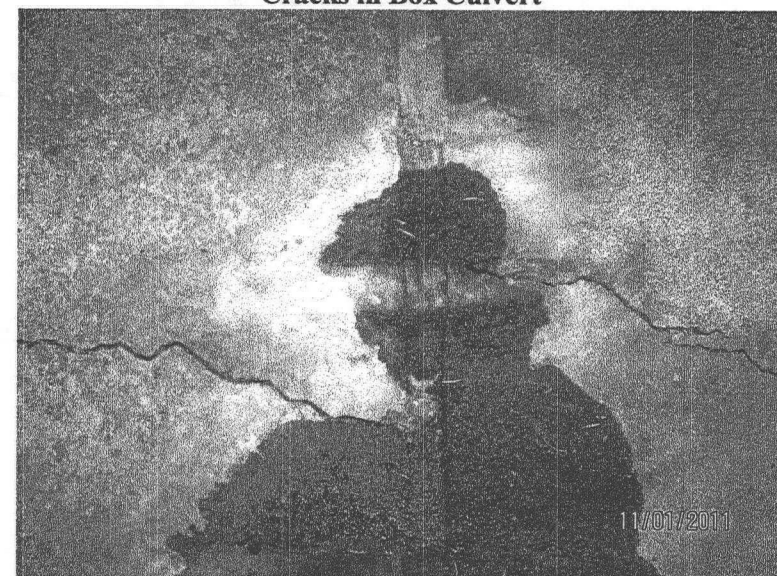
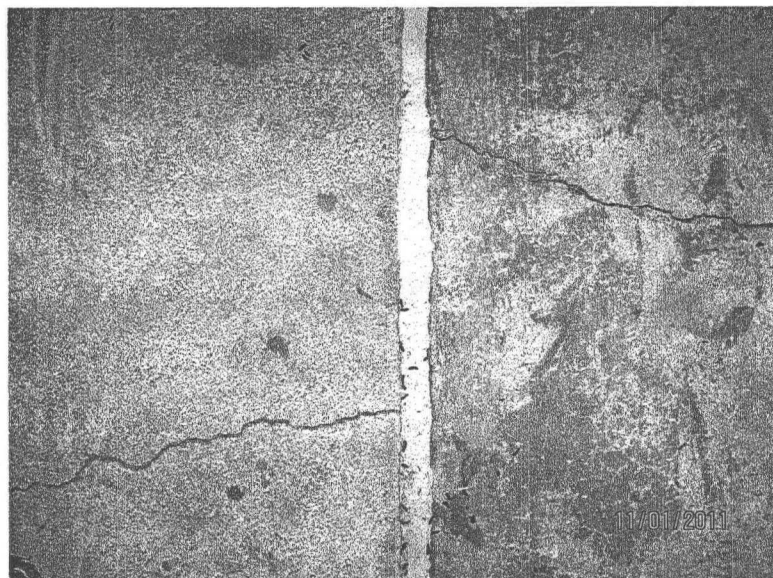
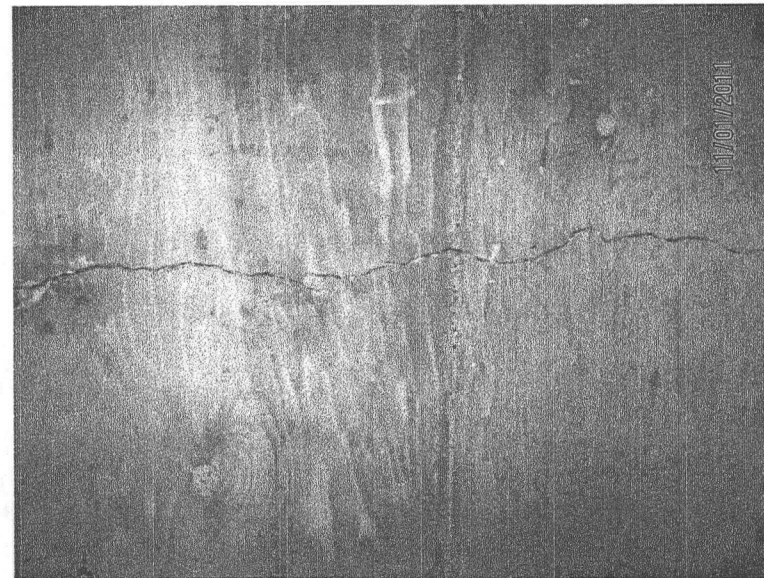
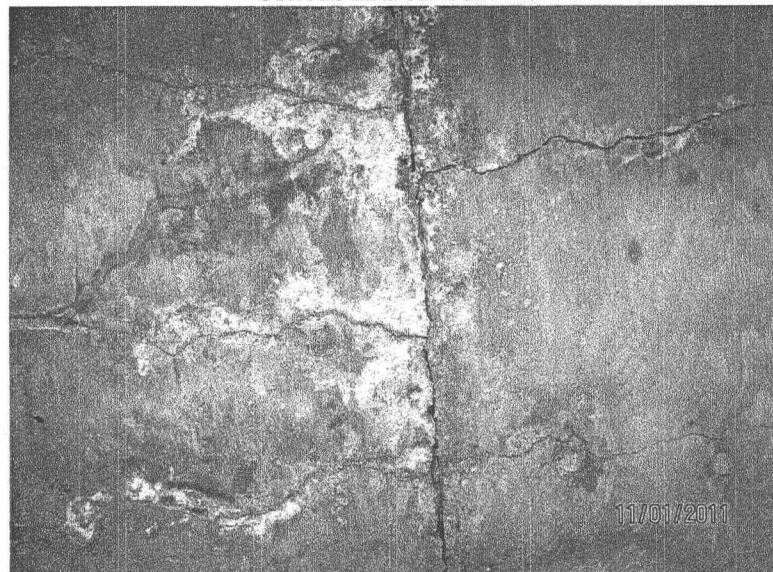
No changes in the spillway have been noted in the past month. Photos of the centerline cracks were taken during this inspection and show no significant changes since spring runoff occurred this spring. There is some debris accumulation occurring but nothing that will hinder flows if they were to occur.

Cracks in Box Culvert
